Hyundai: Tucson/ix35 : 2020- (NX/NX4e/NX4i): Front Wheel Drive

Repair order no.  
R000001

Volkswagen : Golf (Including Variant, Cabrio) : Golf VIII  
2024- (DA/DB) : with Independent Rear Suspension :  
Standard Suspension (G01 G04 G12 G22 G23)

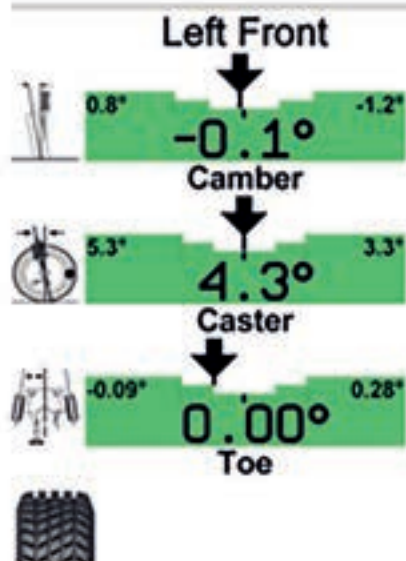
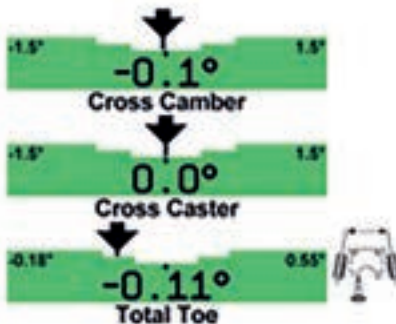
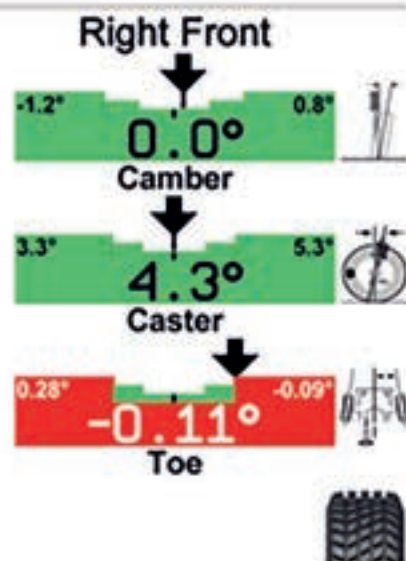
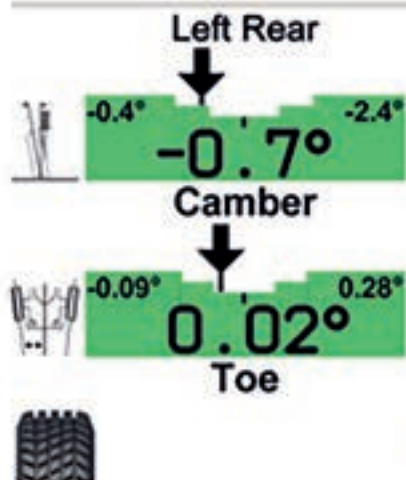
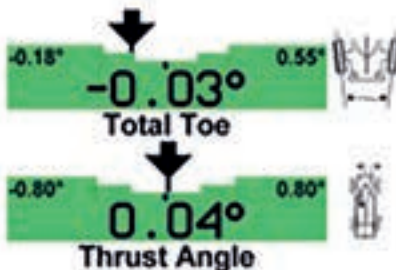
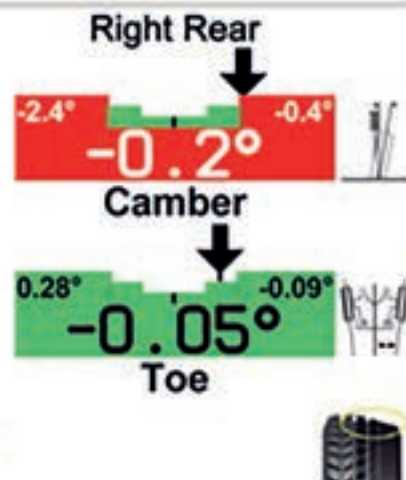
### Before Measurements

• Excessive Camber could cause shoulder wear.

• The steering wheel was level before the alignment.
